INDOOR AIR QUALITY ASSESSMENT

**Charlotte M. Murkland Elementary School
350 Adams Street
Lowell, Massachusetts**

Prepared by:
Massachusetts Department of Public Health
Bureau of Environmental Health Assessment
April, 2002

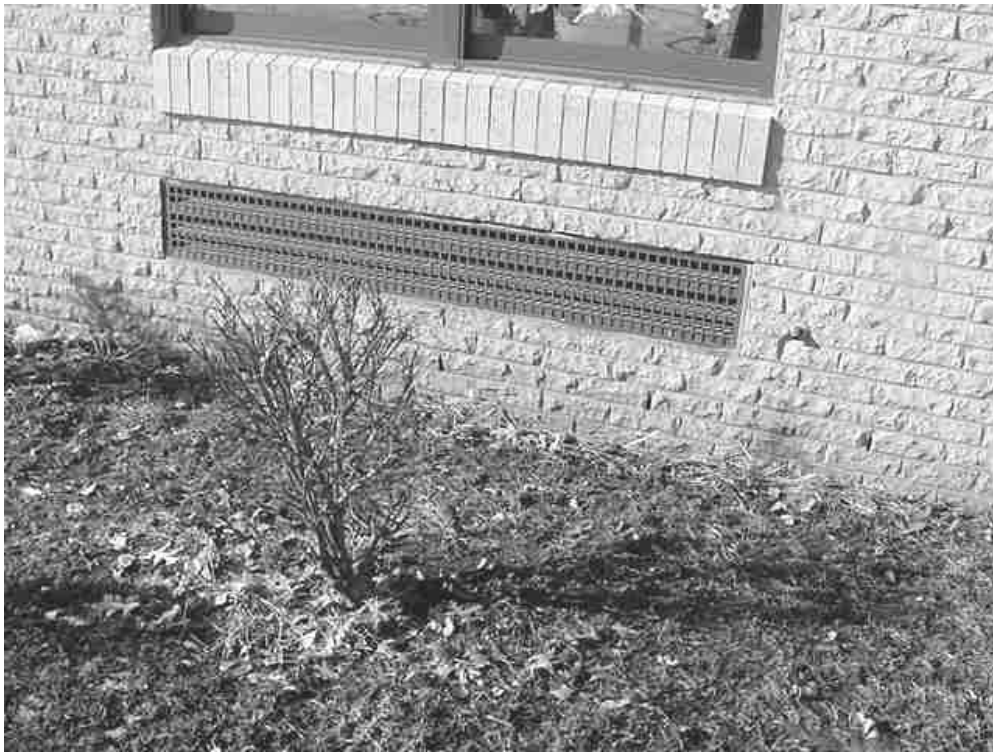
Picture 1

Fresh air in classrooms is supplied by wall or ceiling-mounted unit ventilators (univents) (see Figure 1). Univents draw air from outdoors through a fresh air intake located on the exterior walls of the building (see Picture 1) and return air through an air intake located at the base of each unit. The mixture of fresh and return air is drawn through a filter and a heating coil, and is then expelled from the univent by motorized fans through fresh air diffusers. Univents were operating in all areas surveyed. Obstructions to airflow, such as books, papers and posters on top of univents, as well as desks and carts in front of univent return vents, were seen in a number of classrooms (see Picture 2). To function as designed, univents and univent returns must remain free of obstructions.

Univent Fresh Air Intake

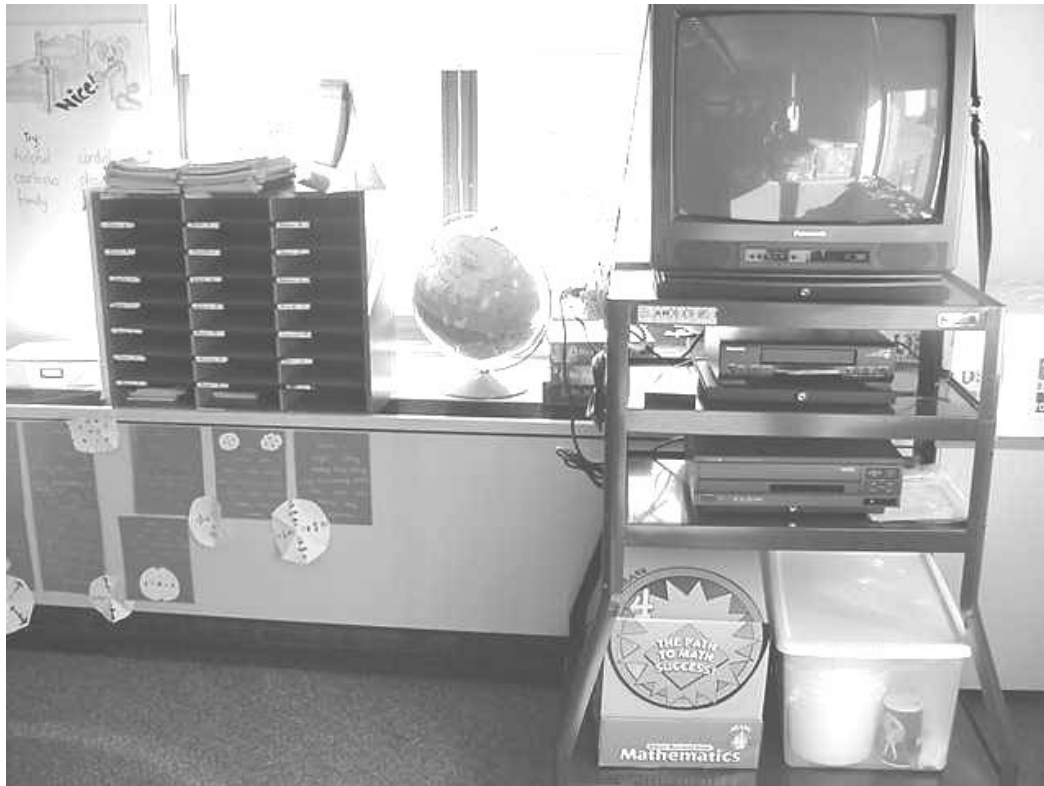
Picture 2

Items on Top of and in Front of Univent

- heating, ventilation and air conditioning (HVAC) engineer concerning the calibration of univent fresh air control dampers school-wide.
5. Remove all blockages from univents and exhaust ventilators to ensure adequate airflow. Clean out interiors of univents.

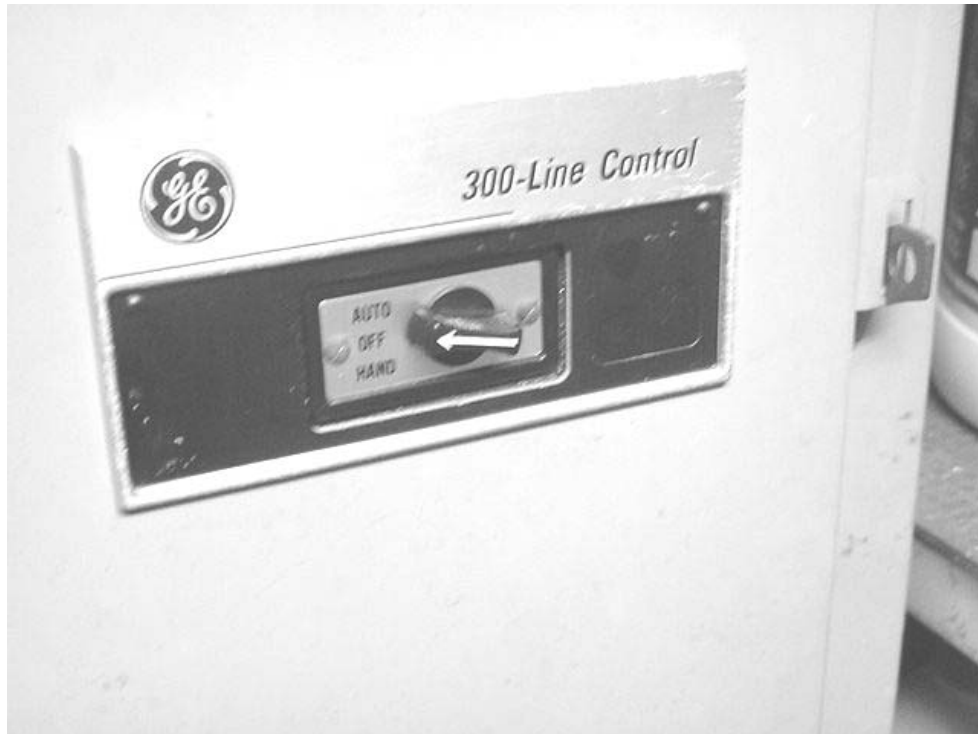
Picture 3

Ventilation in the gymnasium, cafeteria, interior rooms and offices is provided by air handling units either located in mechanical rooms or on the roof. Complaints of stuffiness and lack of circulation thought to contribute to symptoms (e.g., itchy eyes, respiratory irritation) were reported in the main office suite, which includes the nurse's office. No airflow was detected in any of the rooms in this area. It was determined that the panel switch controlling the HVAC system in this area had been deactivated (see Picture 3). Without the HVAC system operating as designed, normally occurring pollutants cannot be diluted or removed allowing them to build up and lead to indoor air quality/comfort complaints.

Control Switch Deactivating AHU in Main Office Suite

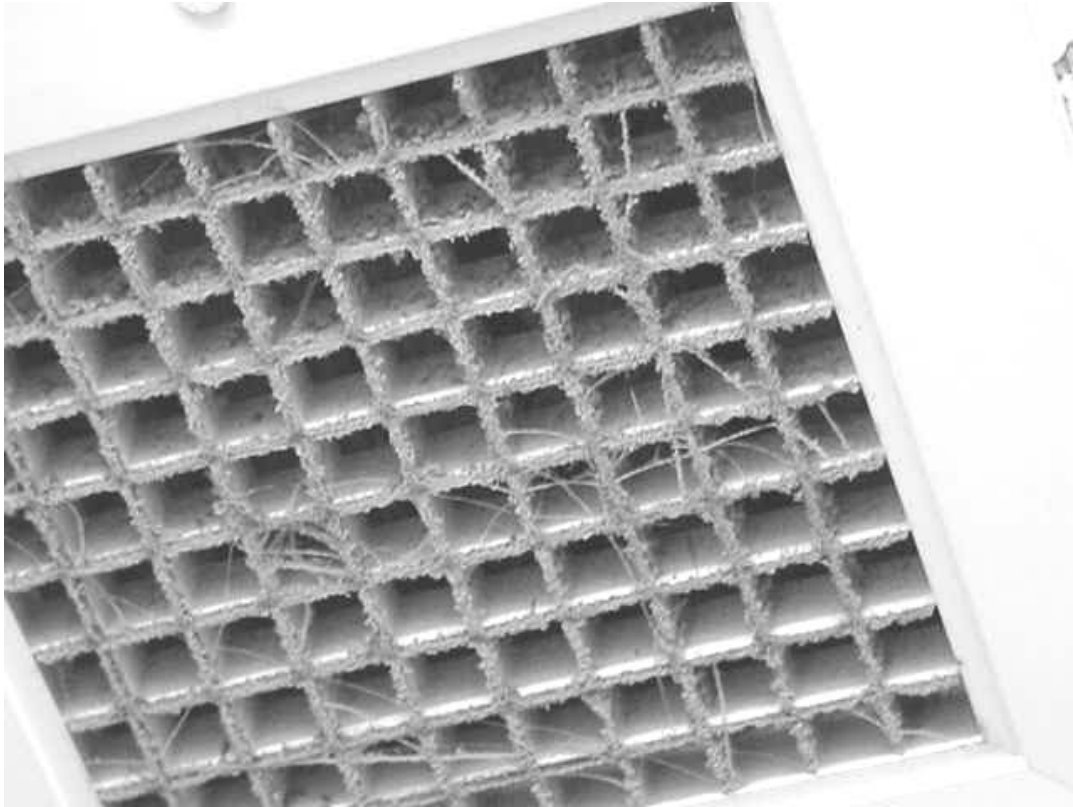
Picture 4

The mechanical exhaust ventilation system consists of ceiling-mounted exhaust vents (see Picture 4). Exhaust vents were not functioning in a number of classrooms, which can indicate that the exhaust ventilation was deactivated, or that rooftop motors were not functioning. BEHA staff examined exhaust motors on the roof and found exhaust motors REF-2 & REF-5 were not operating. In addition, exhaust ventilation for the classroom 101 restroom was not operating at the time of the assessment.

**Ceiling-Mounted Exhaust/Return Vent,
Note Dust/Cobweb Accumulation**

17. Periodically clean exhaust vents of accumulated dust and debris.
18. Consider removing or replacing vinyl mats in pre-kindergarten classroom 101.
19. Relocate student drop off area or consider posting signs instructing drivers to shut off engines after five minutes as required by Massachusetts General Laws 90:16A.

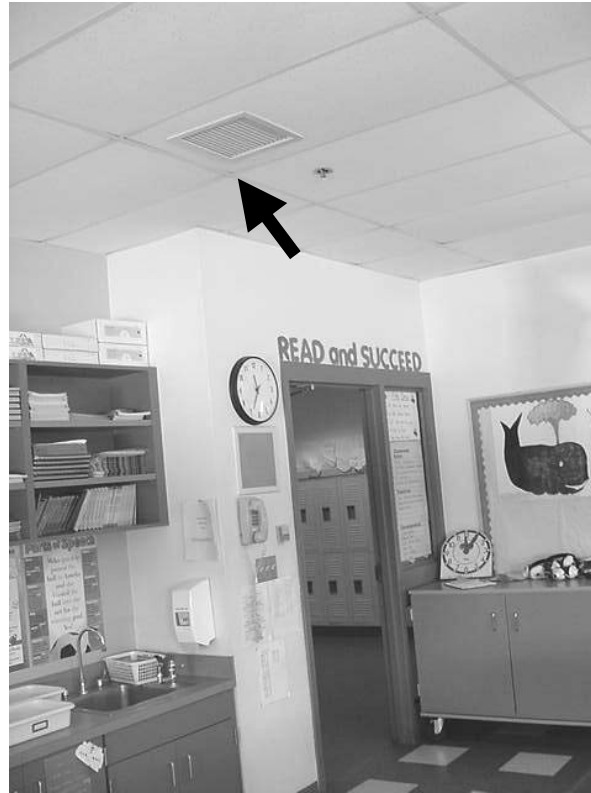
Picture 5

The location of some exhaust vents can limit exhaust efficiency when the classroom hallway doors are open (see Picture 5). When a classroom door is open, exhaust vents will tend to draw air from both the hallway and the classroom. The open hallway door reduces the effectiveness of the exhaust vent to remove common environmental pollutants from classrooms. Without removal by the exhaust ventilation, normally occurring pollutants can build up and lead to indoor air complaints.

Proximity of Ceiling-Mounted Exhaust Vent to Hallway Door

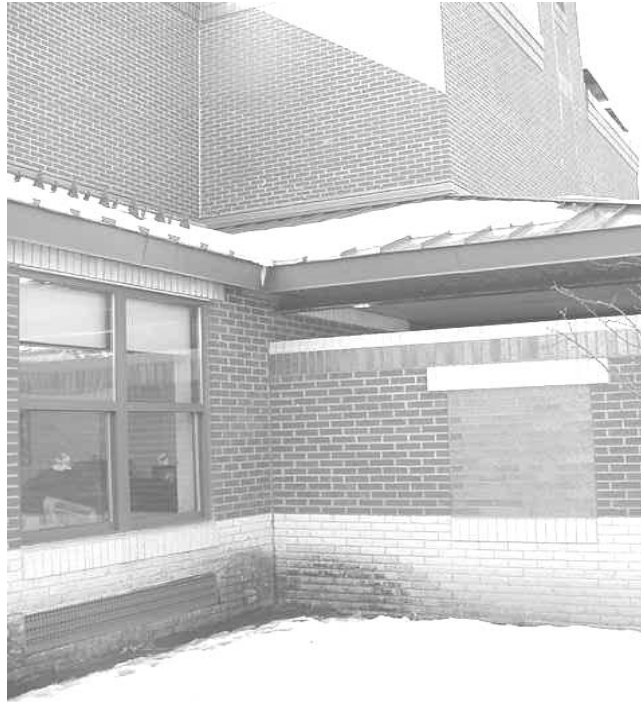
Picture 6

A perimeter inspection of the building was conducted in which BEHA staff noted a potential problem due to the lack of a complete drainage system. Pictures 6-8 depict a green organic material (possibly moss or algae) growing on exterior brickwork near the main entrance of the building. The pattern and location of growth is consistent in areas equipped with metal roofs that are not equipped with gutters or downspouts. The lack of proper drainage allows back-splashing rainwater to impact on the ground below and chronically wet the exterior walls.

Gutters and downspouts are designed to collect and direct rainwater away from the base of the building to prevent the chronic wetting of exterior walls which can result in damaged brickwork and/or mold growth. Over time rainwater can work its way into mortar and brickwork causing cracks and fissures, which can lead to water penetration as well as the increased degradation of structural integrity.

**Metal Roof not Equipped with Gutters/Downspouts;
Note Staining/Water Damage of Brickwork Due to Backsplashing**

11. Inspect/install drainage to prevent the impact of back-splashing rainwater on exterior brickwork. Remove growth and disinfect areas on exterior brickwork with an appropriate antimicrobial as needed.

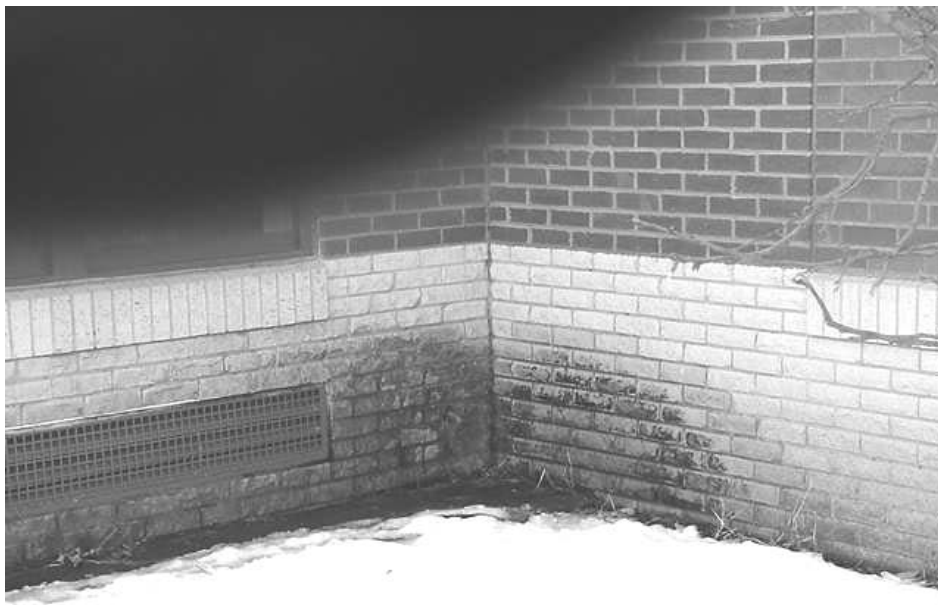
Picture 7

Close-up of Water Stained/Damaged Brickwork

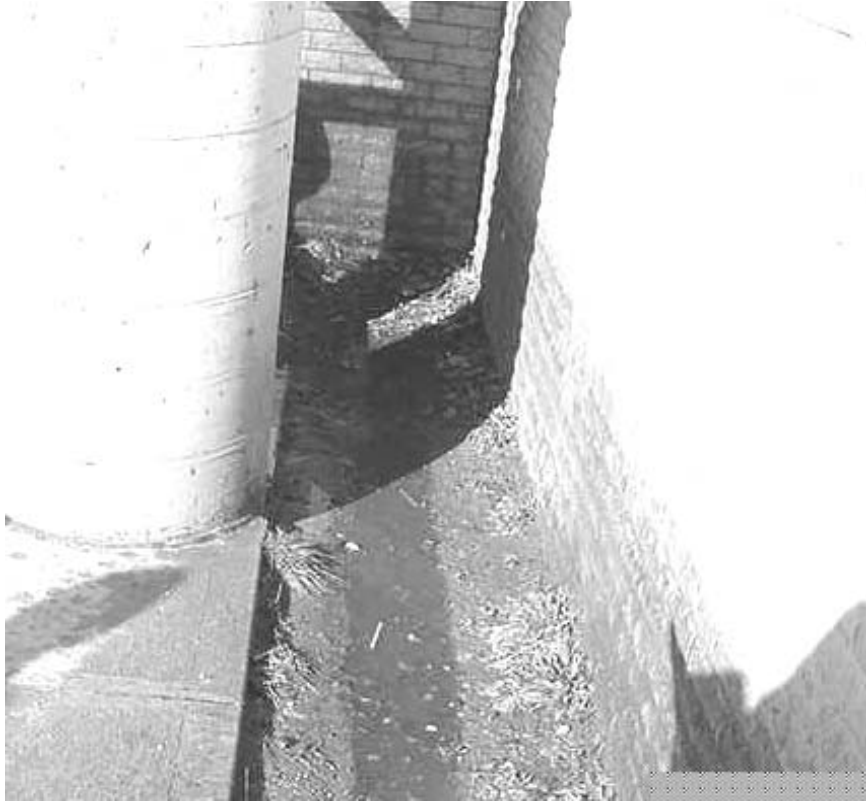
Picture 8

**Brickwork (Near Front Entrance) Impacted by Lack of Drainage;
Note Standing Water in Trench Parallel to Exterior Wall**

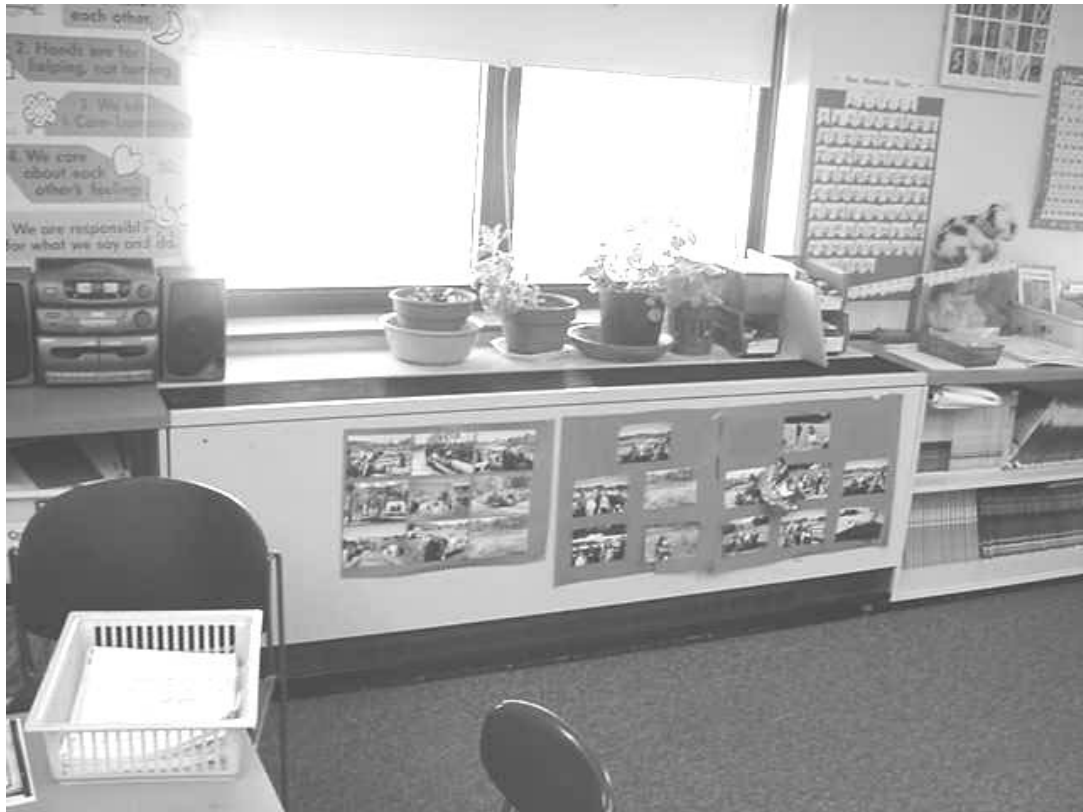
Picture 9

Several classrooms had a number of plants. Moistened plant soil and drip pans can be a source of mold growth. The lack of drip pans can lead to water pooling and mold growth on windowsills. Plants are also a source of pollen. Plants in several classrooms were noted near univent air diffusers (see Picture 9). Plants should be located

away from the air stream of ventilation sources to prevent the aerosolization of mold, pollen or particulate matter throughout the classroom.

Flowering Plants on Top of Univent

8. Calibrate, repair and/or replace thermostats as necessary to maintain control of comfort.
 9. Keep plants away from univents in classrooms. Ensure plants have drip pans, avoid over-watering, and examine drip pans for mold growth and disinfect areas with an appropriate antimicrobial where necessary.

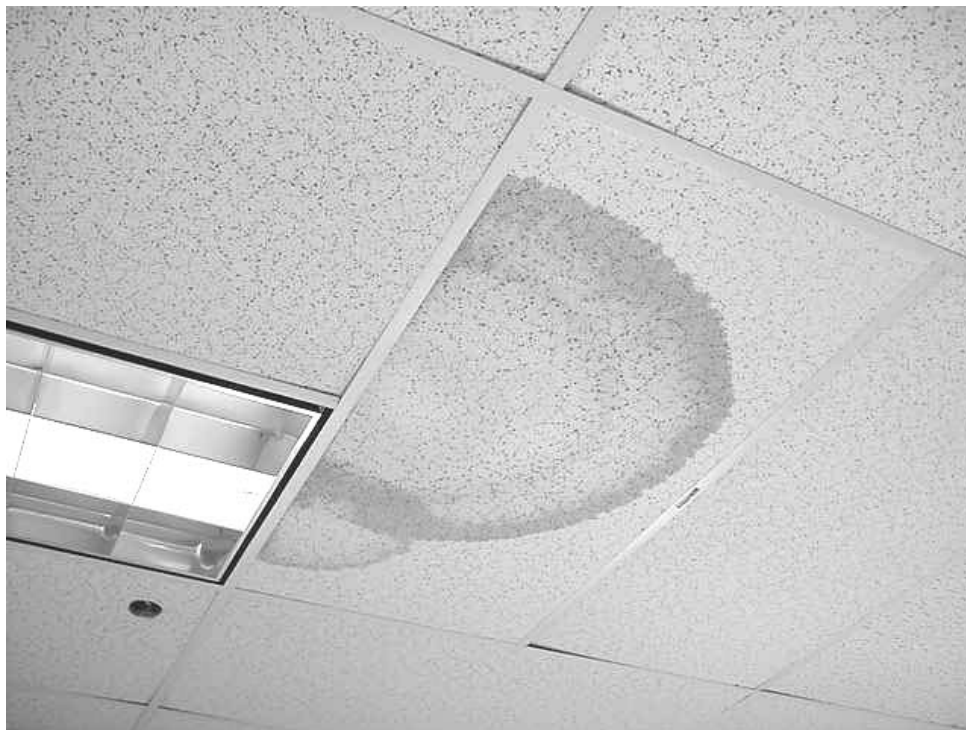
Picture 10

A few water-damaged ceiling tiles were noted reportedly from historic roof leaks and/or from the HVAC system (see Picture 10). If wetted repeatedly, porous materials can grow mold and be a source of unpleasant odors. Water-damaged building materials should be replaced after a water leak is discovered.

Water-Damaged Ceiling Tiles

10. Replace any remaining water-stained ceiling tiles, wall board and pipe insulation. Examine the areas above and around these areas for mold growth. Repair water leaks and disinfect areas of water leakage with an appropriate antimicrobial if necessary.

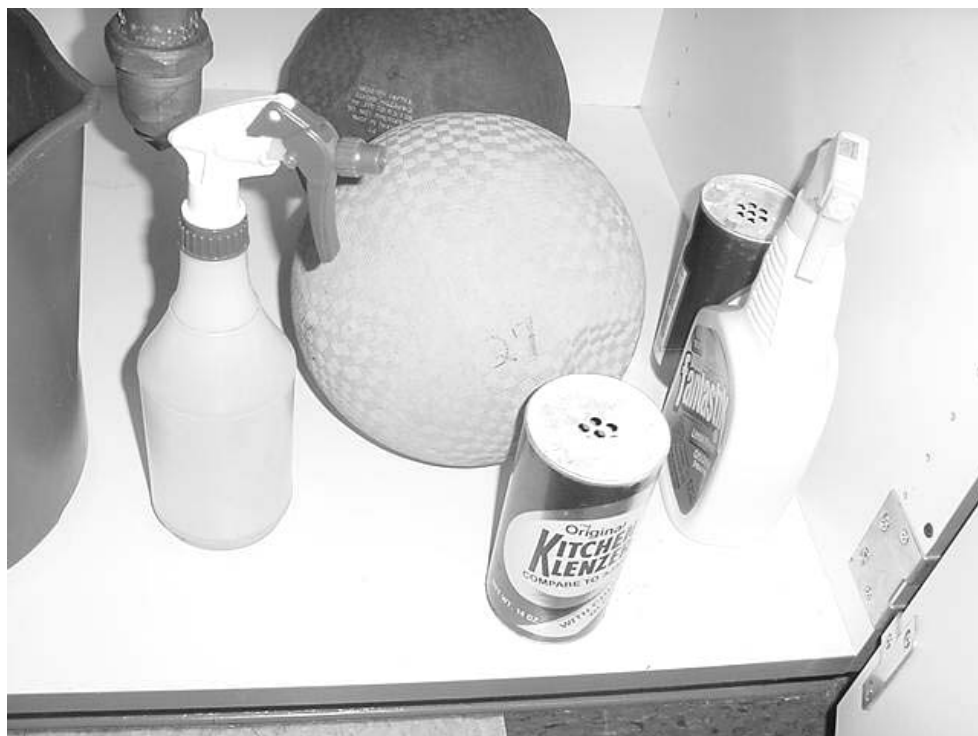
Picture 11

Several other conditions were noted during the assessment, which can affect indoor air quality. Cleaning products and other unlabeled materials were found on counter-tops and beneath sinks in a number of classrooms (see Picture 11). A number of classrooms contained unlabeled spray bottles. Products should be kept in their original containers or clearly labeled as to their contents for identification purposes in the event of an emergency. The scent of deodorizer was detected upon entry into the music room and several restrooms. The source of the odors were identified as air fresheners plugged into electrical sockets in restrooms and a conventional time-released air freshener in the music room. Air fresheners and cleaning products contain chemicals that can be irritating to the eyes, nose and throat of sensitive individuals. In addition, air fresheners do not remove materials causing odors, but rather mask odors which may be present in the area.

Cleaning and Unlabeled Products beneath Classroom Sink

12. Do not store paper products or other cellulose-containing materials beneath sinks.
13. Store cleaning products and chemicals properly and keep out of reach of students.

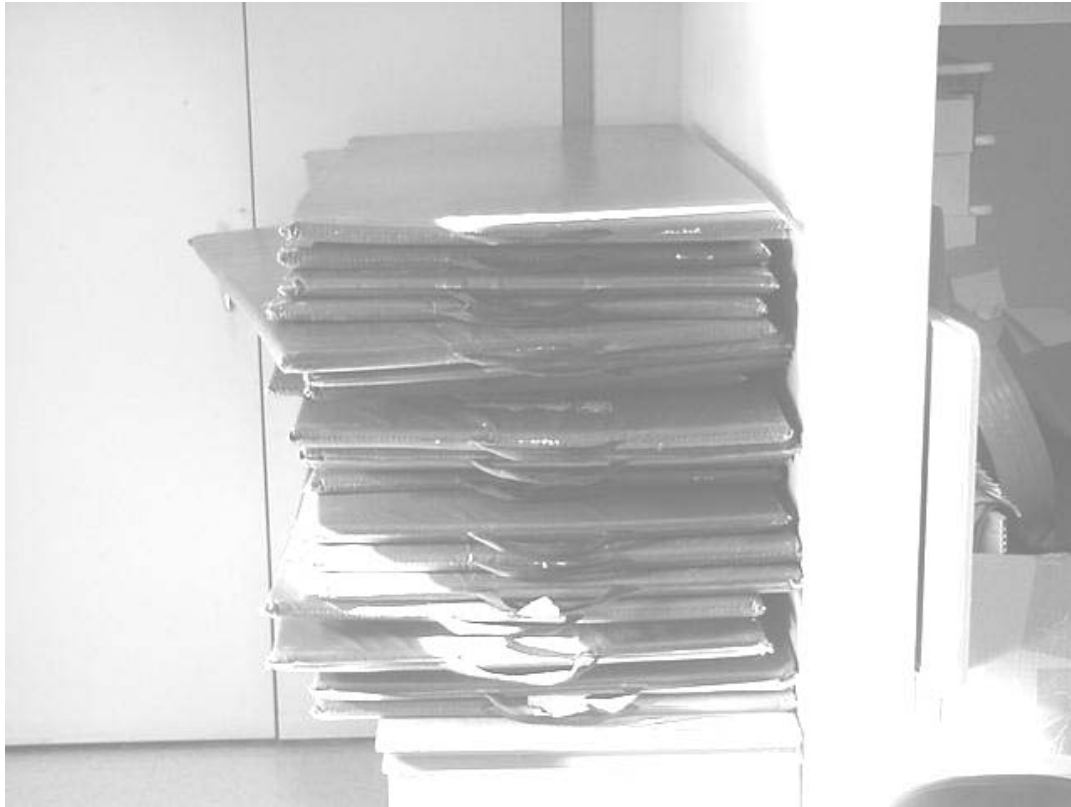
Picture 12

A pungent odor was detected upon entry into pre-kindergarten room 101. This odor was traced to a number of vinyl mats that children use during naptime (see Picture

12). Although no health effects or symptoms were reported, these types of nuisance odors can be problematic for certain sensitive individuals.

Vinyl Mats Emitting Odors Found in Pre-Kindergarten Classroom 101

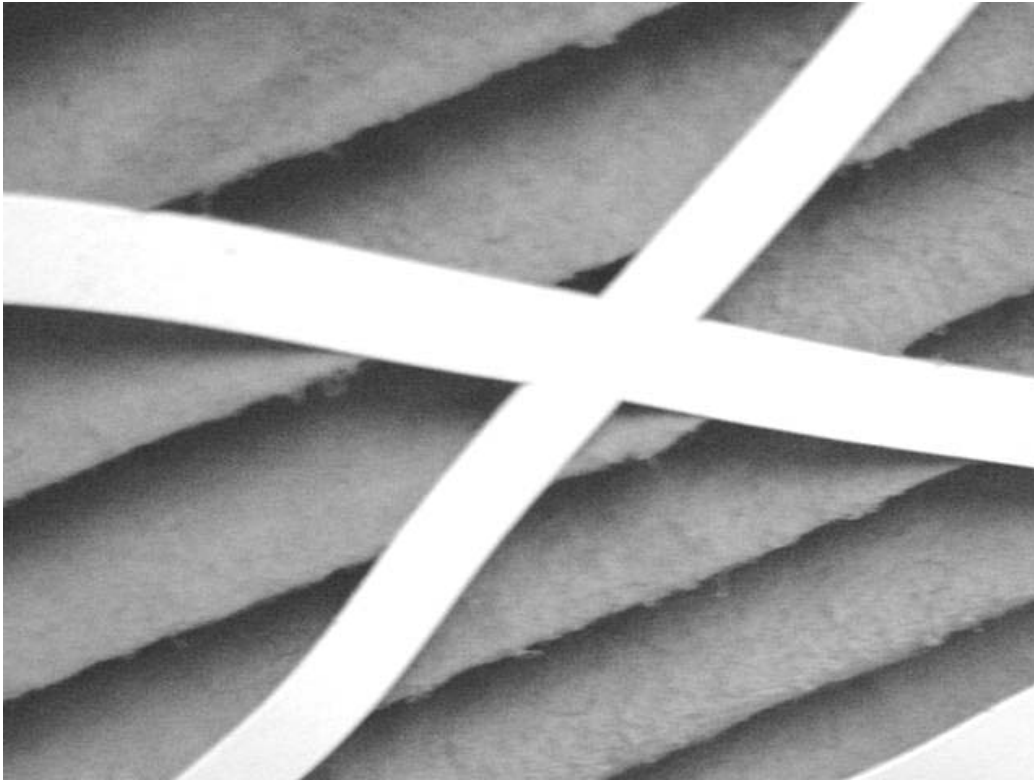
Picture 13

BEHA staff examined filters in AHUs in mechanical rooms and on the roof and found filters coated with dirt/dust and accumulated material (see Pictures 13 & 14). A debris-saturated filter can obstruct airflow and may serve as a reservoir of particulates that can be re-aerosolized and distributed to occupied areas via the ventilation system. School officials reported that the Lowell Department of Public Works (LDPW) is responsible for maintaining HVAC equipment, including filter changes. School officials report that recently school maintenance personnel are allowed to change filters in wall-mounted classroom univents (but not AHUs or ceiling-mounted univents). Although this reallocation of responsibility will benefit certain classrooms, it may create conditions of inconsistent preventative maintenance.

Mechanical Room AHU Filter Covered With Dust/Debris

1. Continue to work with the LDPW to develop a preventative maintenance program for all HVAC equipment.
2. Change filters for AHU equipment as per the manufacturer's instructions or more frequently if needed. It is important that filters for all HVAC equipment (i.e. univents and AHUs) are changed on the same schedule to maintain consistency.
3. To maximize air exchange, the BEHA recommends that both supply and exhaust ventilation operate continuously during periods of school occupancy independent of classroom thermostat control.
4. Examine each univent for function. Survey classrooms for univent function to ascertain if an adequate air supply exists for each room. Consider consulting a

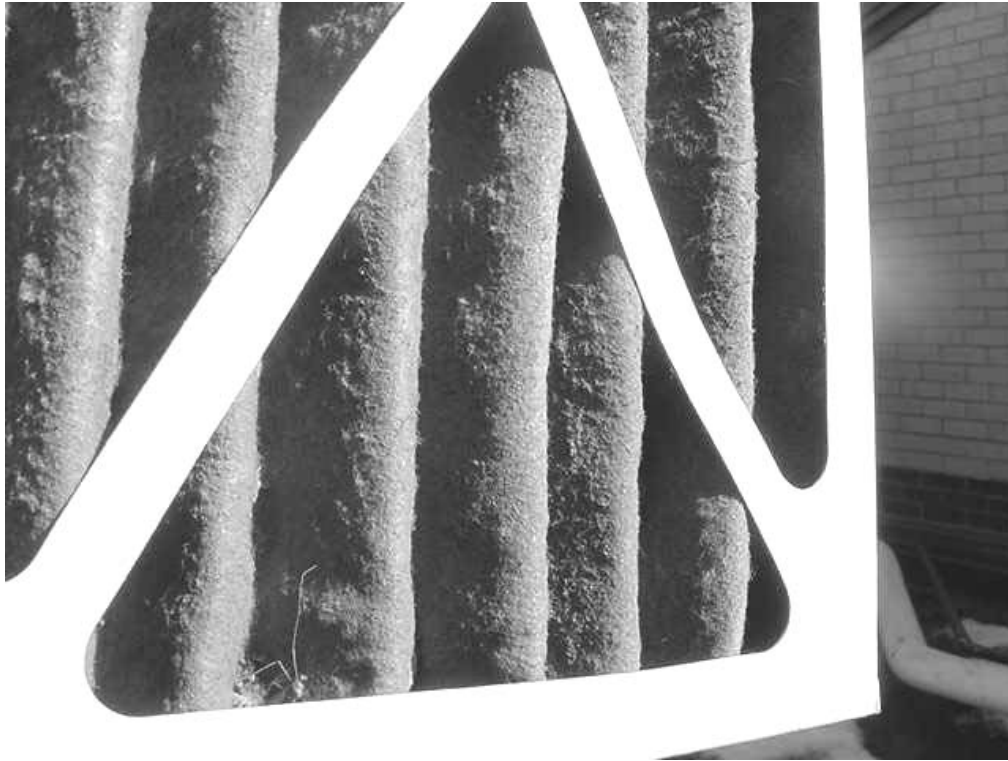
Picture 14

Rooftop AHU Filter Covered With Dust/Debris

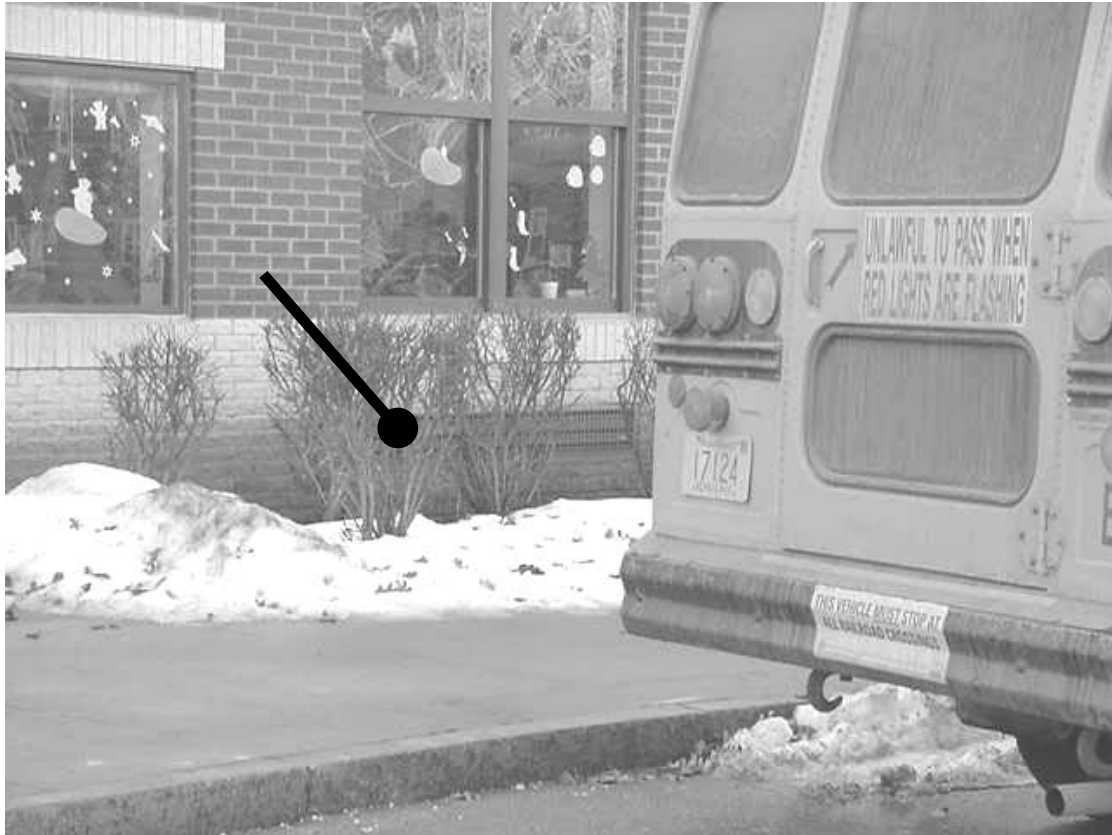
Complaints of vehicle exhaust odors have been reported within the building. Picture 15 depicts the potential for vehicle exhaust to be pulled into the univent fresh air intakes (called entrainment). Idling vehicles can result in the entrainment of vehicle exhaust into the building, which may, in turn, provide opportunities for exposure to compounds such as carbon monoxide. M.G.L. chapter 90 section 16A prohibits the

unnecessary operation of the engine of a motor vehicle for a foreseeable time in excess of five minutes (MGL, 1996).

Mini-bus Idling Outside of Fresh Air Intake During School Hours
